Thomas B. Connolly, AIA
Margaret M. Hickey, AIA
Connolly & Hickey Historical Architects

Fenwick Manor - Historic Preservation Plan

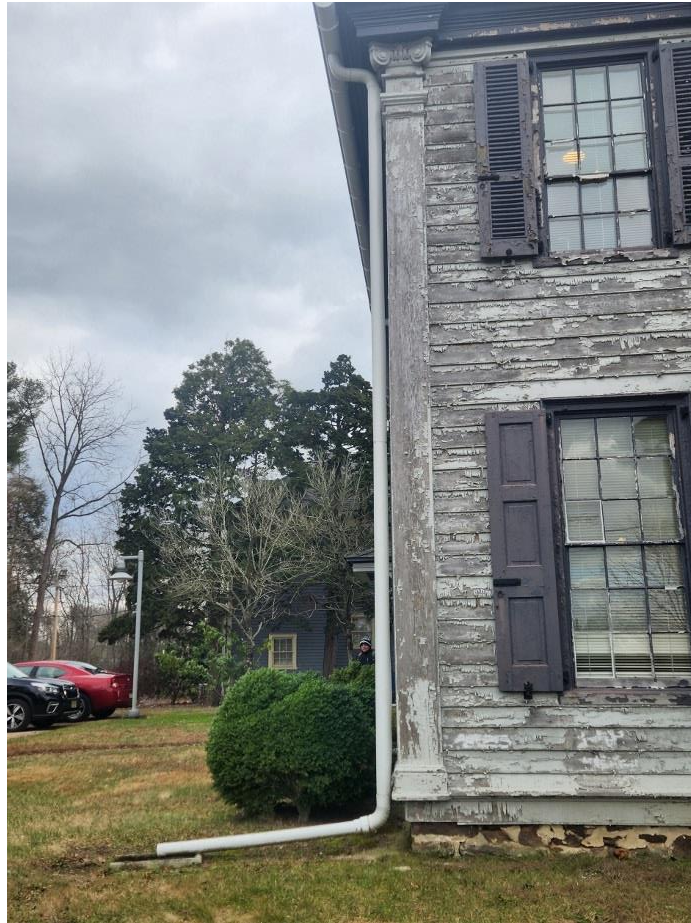
Note the wholesale paint loss on the siding and trim elements. Based on the way the paint is peeling, the lower paint layers have failed causing the paint to check and alligator.

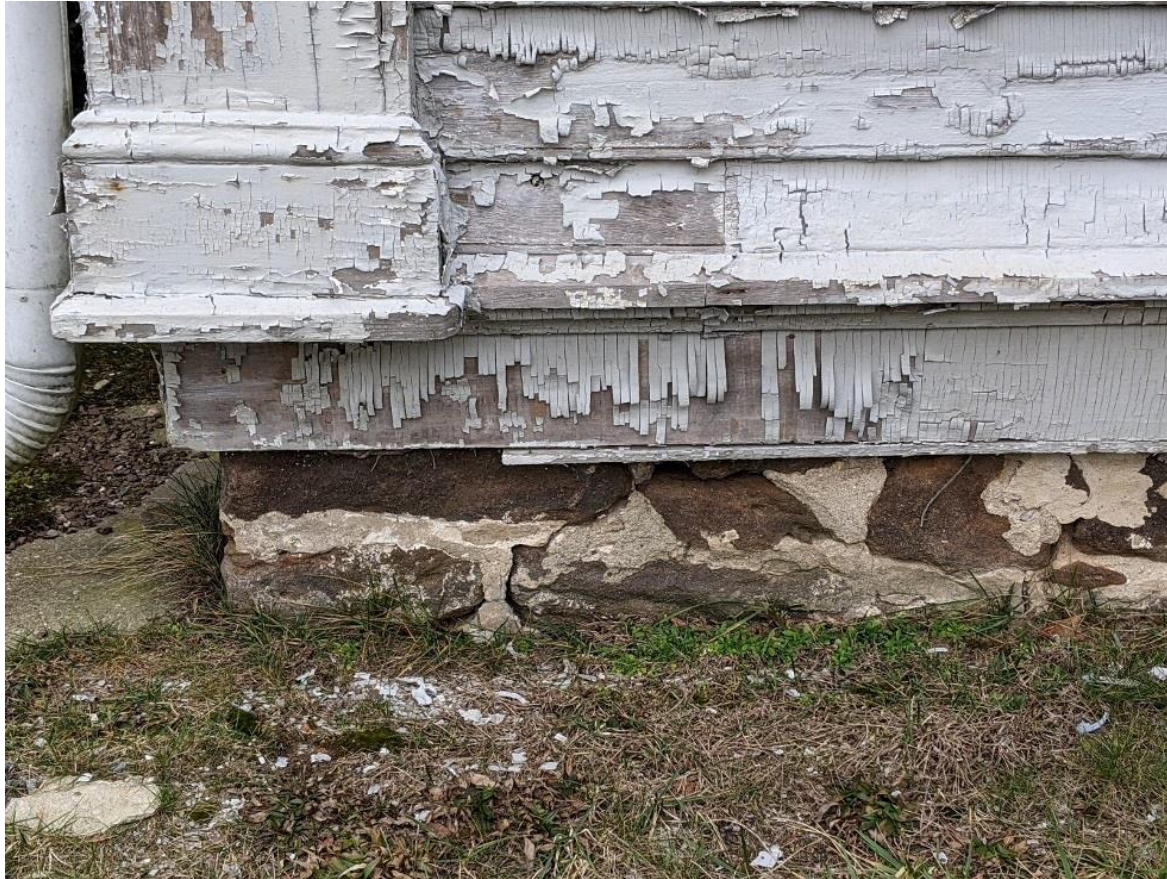
View of mortar loss at the brownstone foundation. Foundations exhibit a mix of mortar and parging loss. Also note paint that has checked, which is severe in many locations.

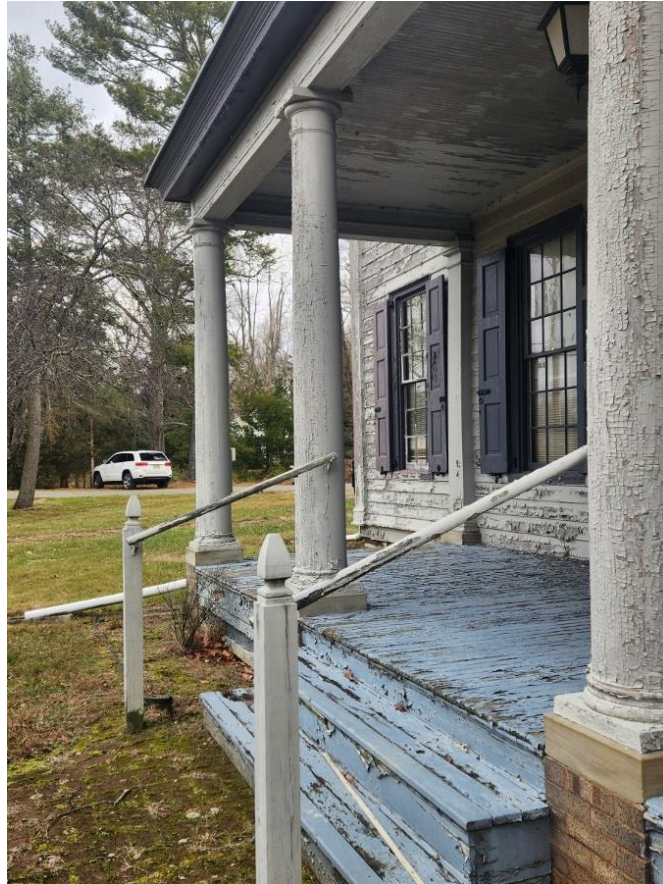
View of the front porch showing wholesale paint loss, which is throughout the painted porch elements.

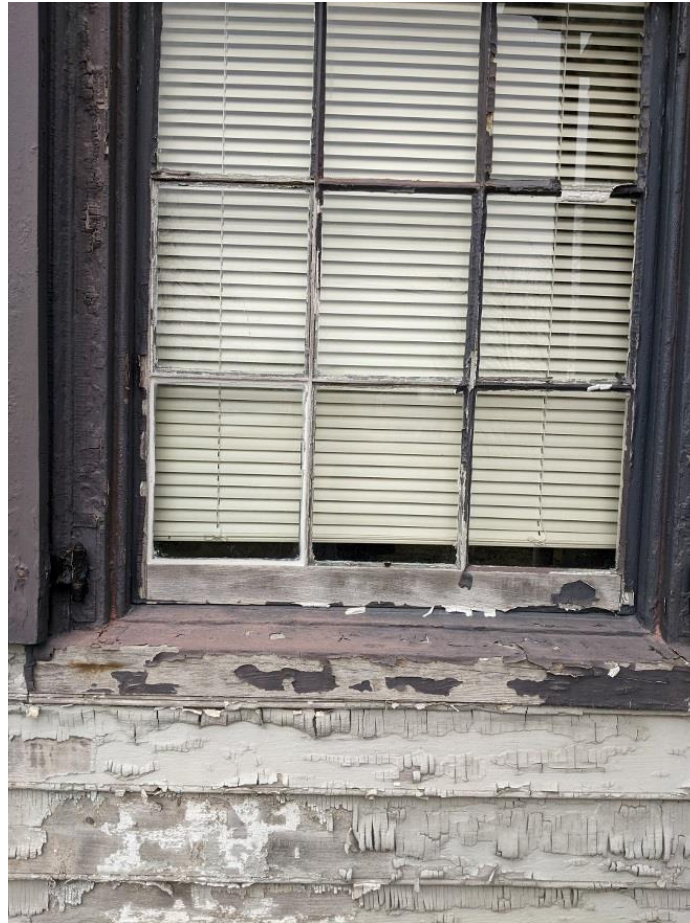
Paint and glazing putty loss is prevalent at many of the wood-hung windows and frames.

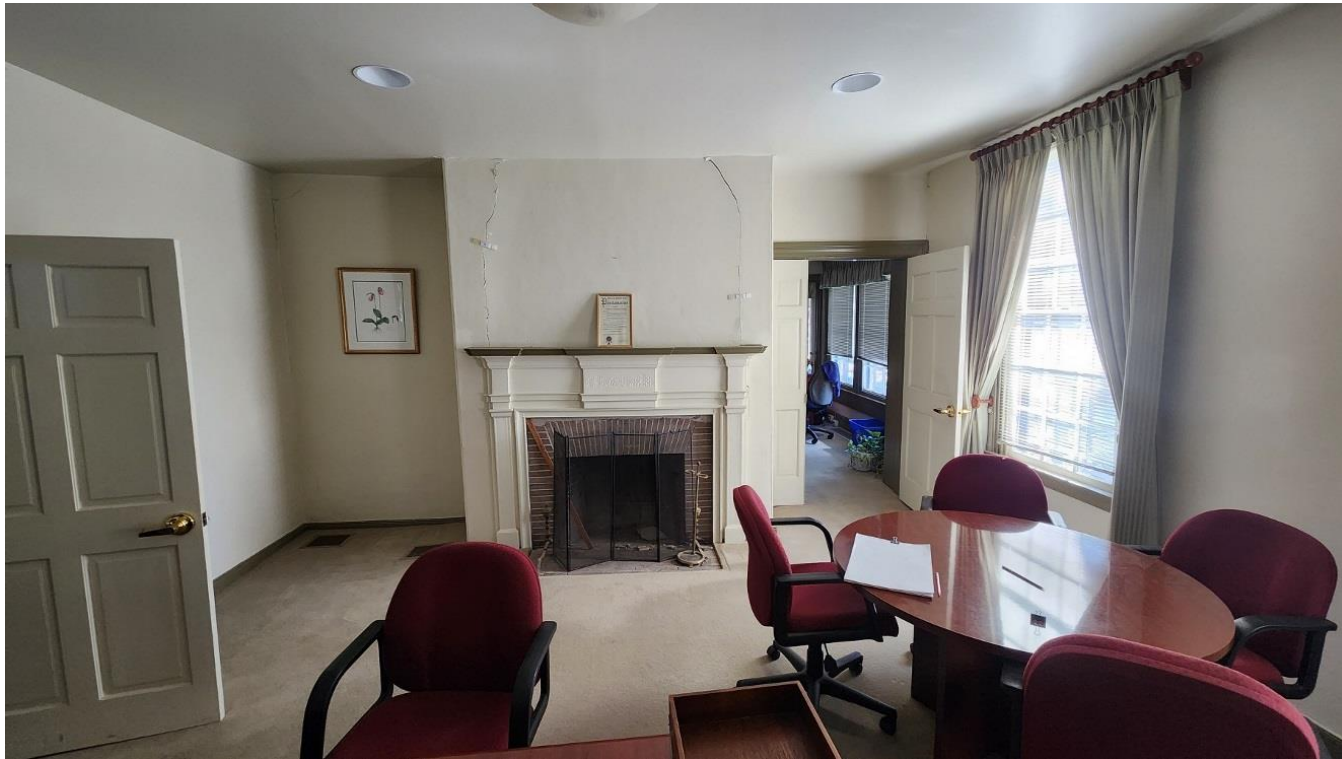
Note the cracking around the fireplace at the southwest parlor; there are other cracks along this entire wall and at the northeast corner of the space.

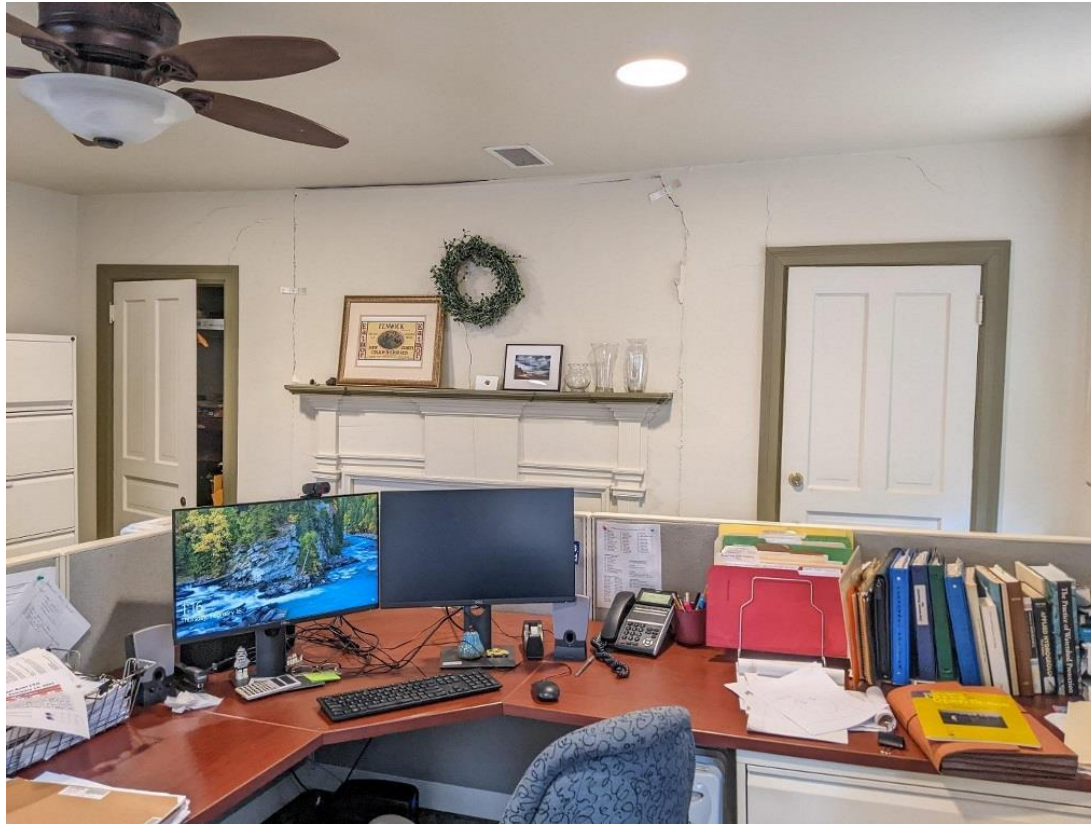
Note the cracking in the plaster around the fireplace in the former southwest bedroom.

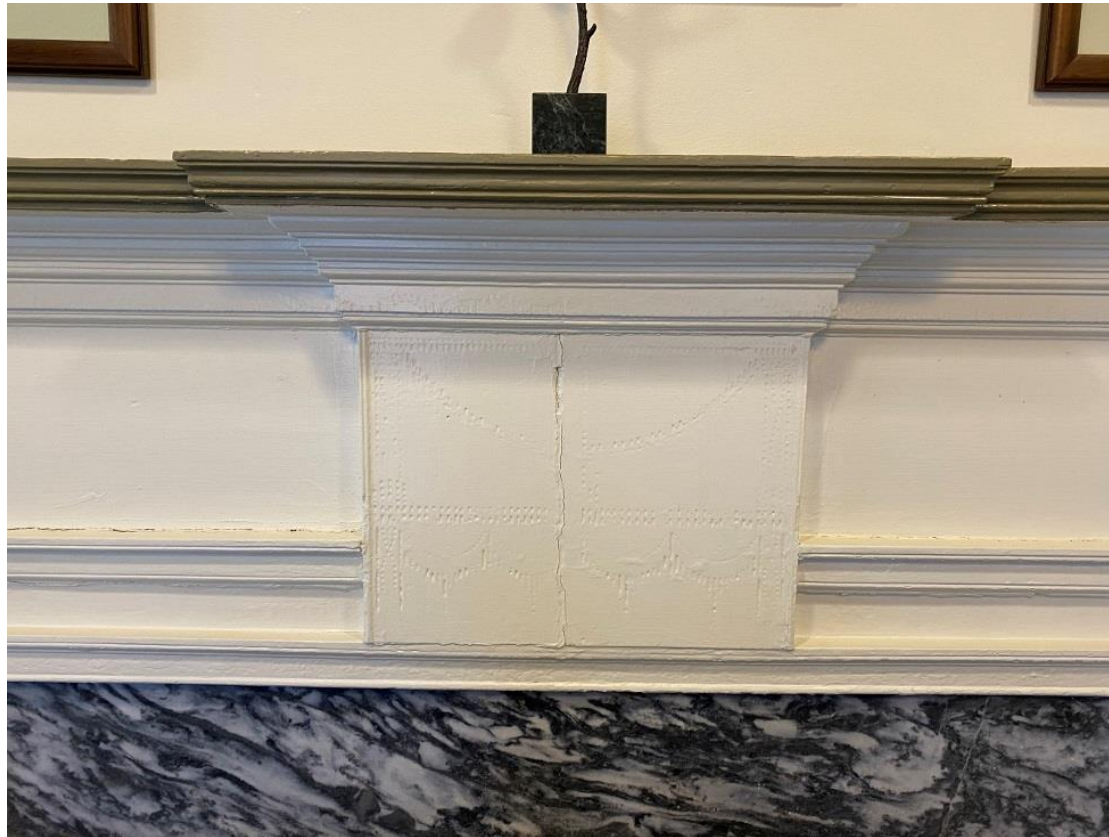
Crack in the mantelpiece of the fireplace in the northwest parlor. There are conditions at this fireplace that indicate the supports here may also be undermined but not to the extent of the fireplace in the southwest parlor.

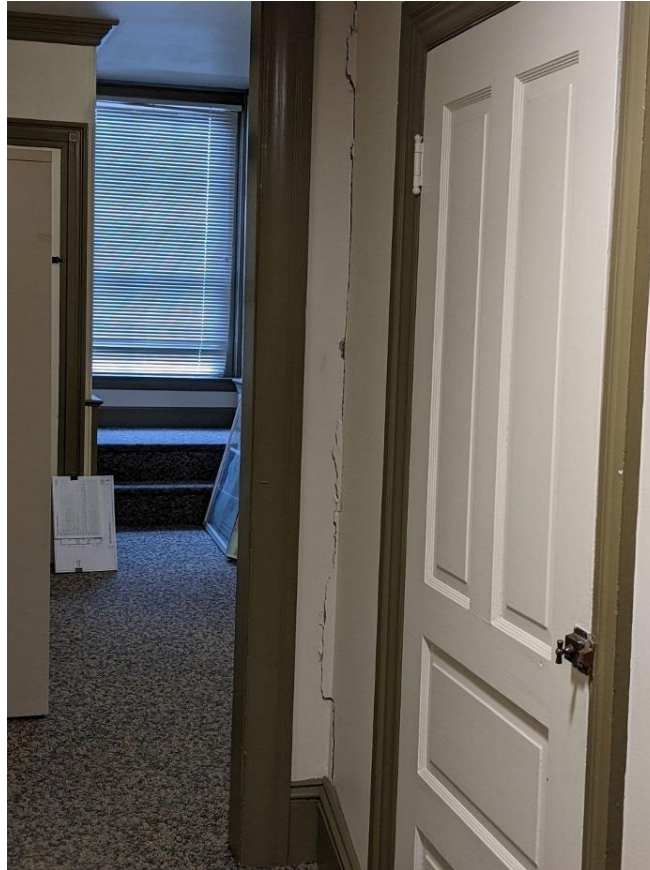
Crack in the plaster at the second floor. It is suspected this crack is caused by the foundation problems with the fireplace in the southwest parlor, which translate to the upper stories.

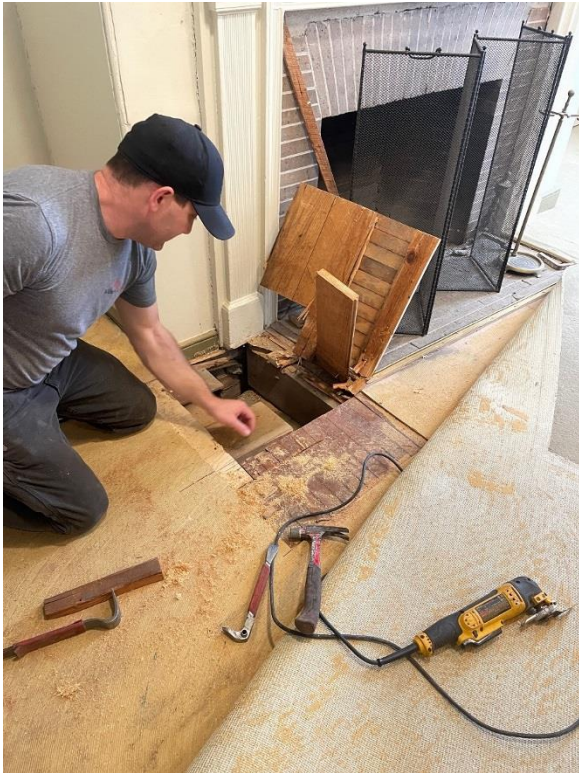
Removal of flooring in southwest parlor to investigate the condition of the fireplace supports.

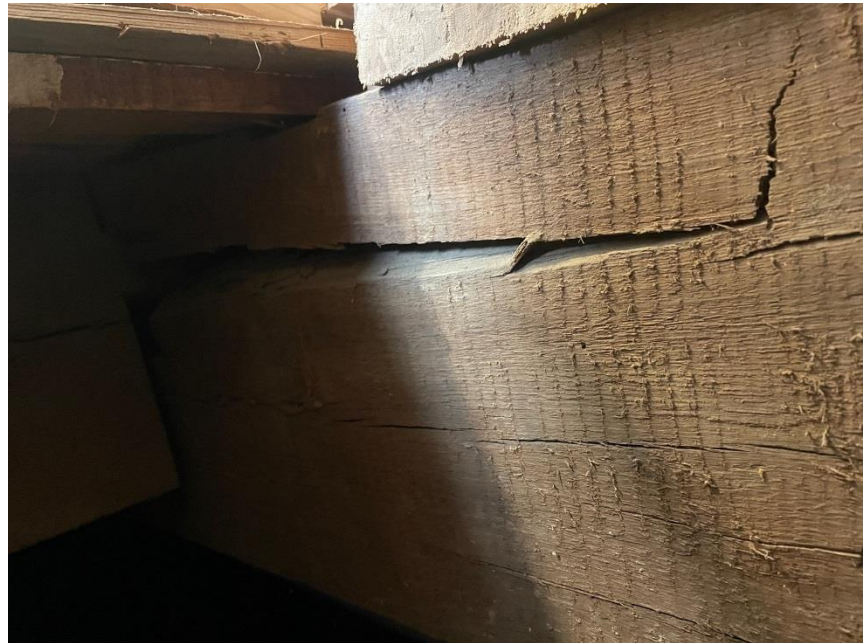
View the cracked fireplace header, which supports three levels of brick masonry.

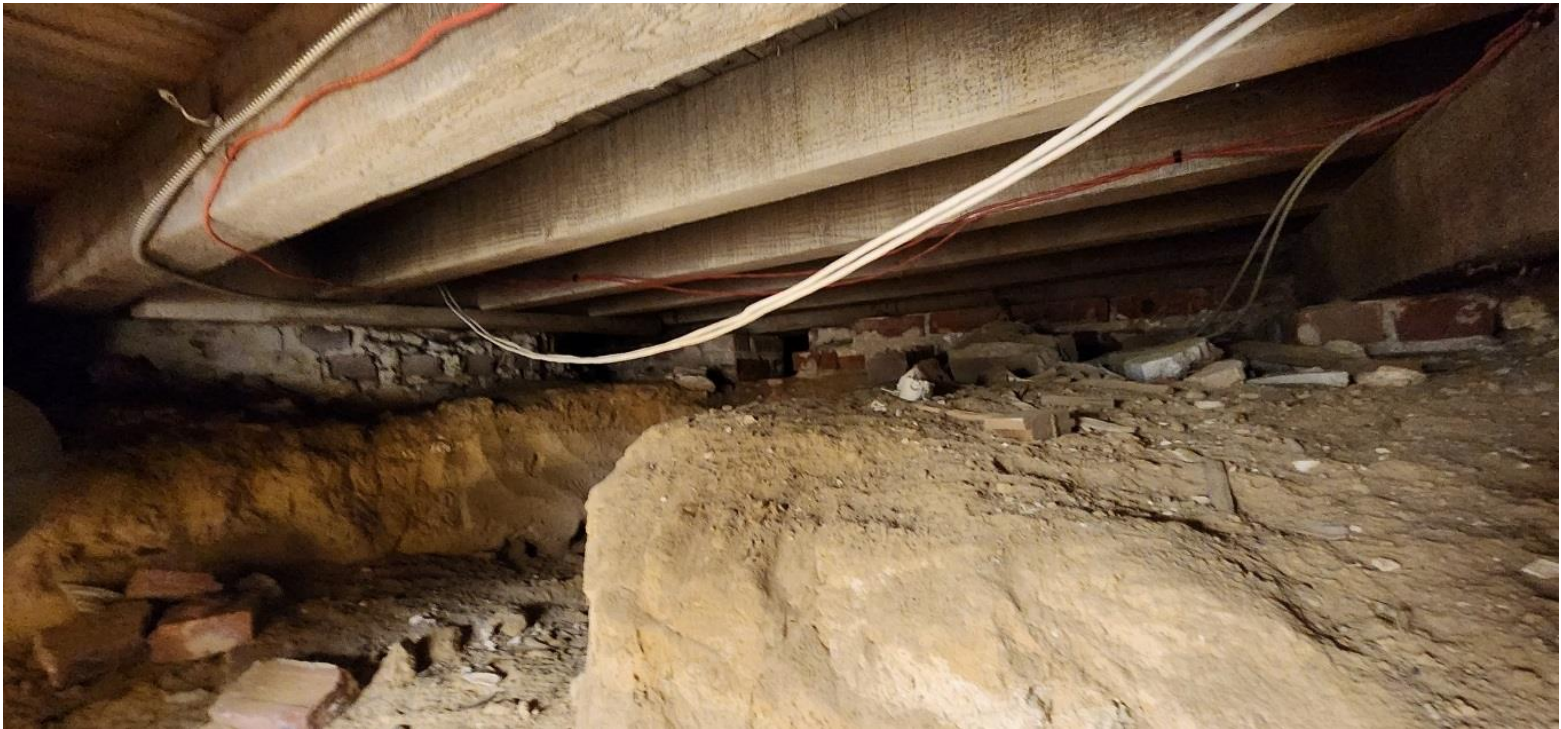
View of the crawlspace looking northeast showing how portions of the crawlspace have been dug out.
