PMP Implementation at Deepwater Energy Center

PCB PMP Conference October 22, 2012

May Johnson - Calpine Art Saunders - Cardno ENTRIX

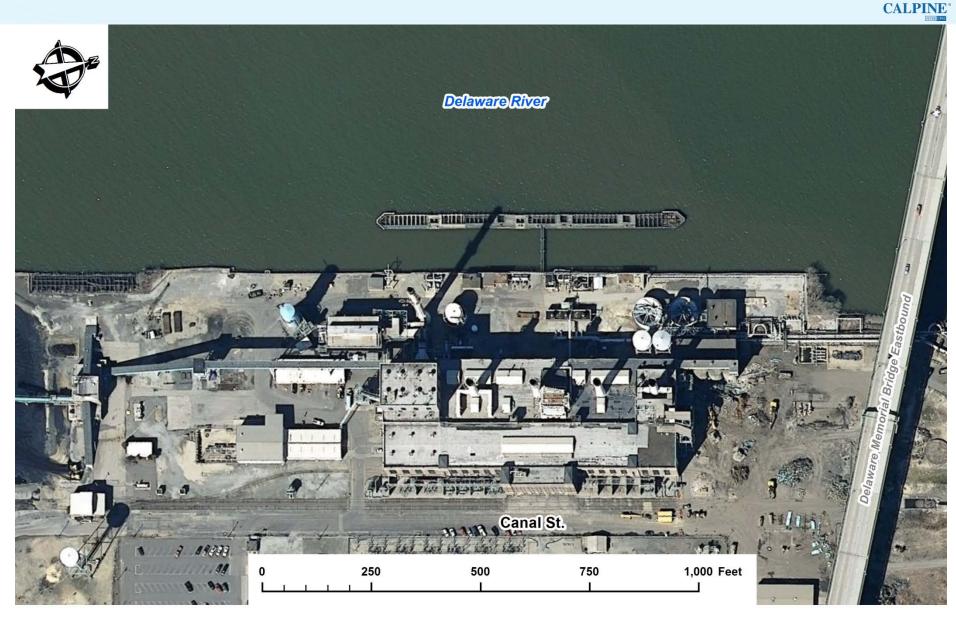
Deepwater Energy Center - Aerial View

Location

- –DE River Mile 68
- -Directly South of DE Memorial Bridge

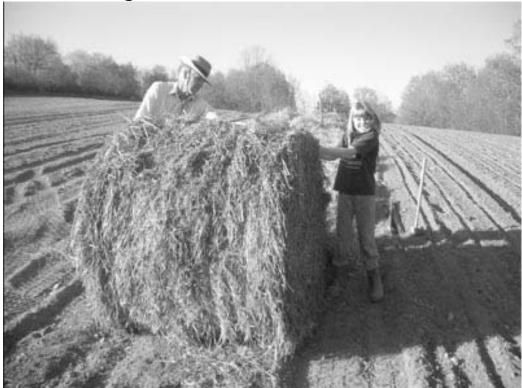
Initially, hay bales were deployed around storm drains and in strategic drainage areas

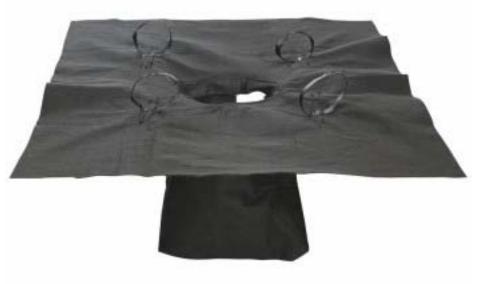
- Upgraded to using geotext filter baskets (used in addition to hay bales) for all storm drains & catch basins within DSNs 017 and 002
- maintained regularly
- Cost: \$100-\$120 per unit

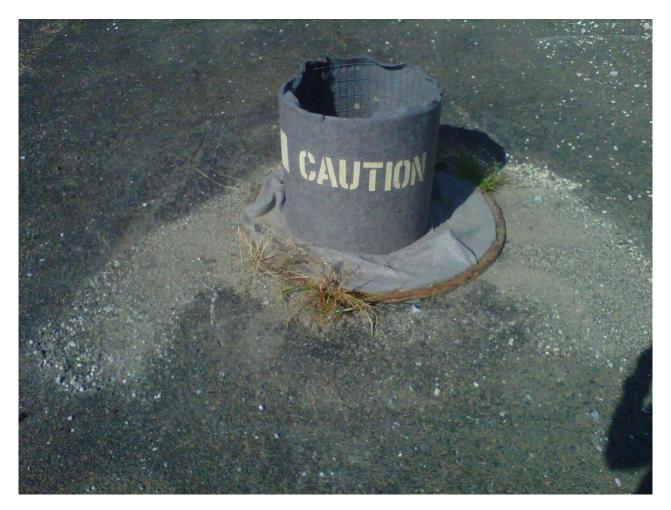
Replaced messy hay bales with Basin Guards

- Prevent silt, sediment and hydrocarbons from entering storm drains
- Provide visual indicators to storm drain locations
- Help comply with NPDES, 40 CFR 122.26 (1999) when used as Best Management Practice in Storm Water Pollution Prevention Plans.
- Cost: \$100-120 per unit

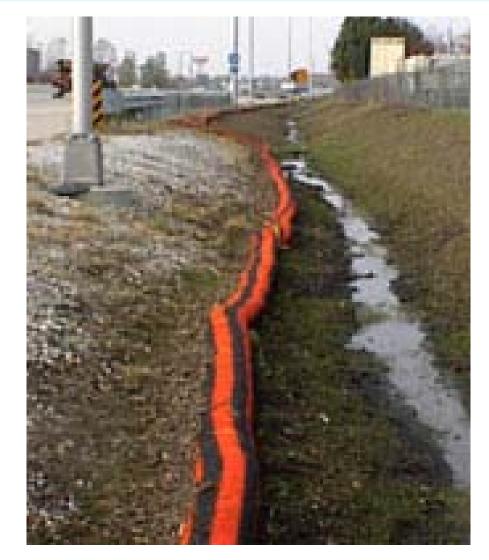
- Installed filter socks in strategic areas to filter particulates from storm water drainage
- Cost ~\$2/foot (2006)

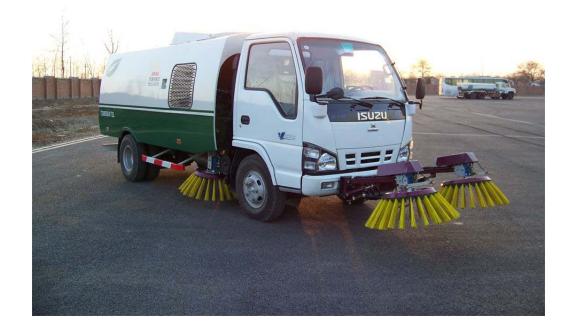
- Contracted a street sweeping service to periodically clean paved areas within DSNs 017 and 002
- Cost: ~\$400 per "sweep"

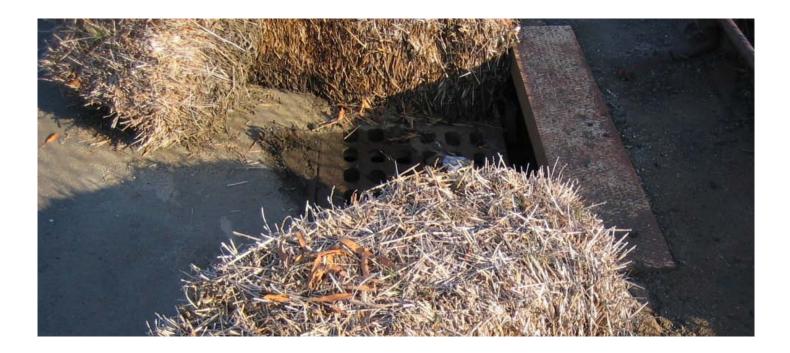
- Basic plan was to "start simple", and expand trackdown efforts as needed.
- Since most of the catch basins contained sediment both within the catch basin, and on the paved surface immediately adjacent to the catch basin, the sampling efforts started there.

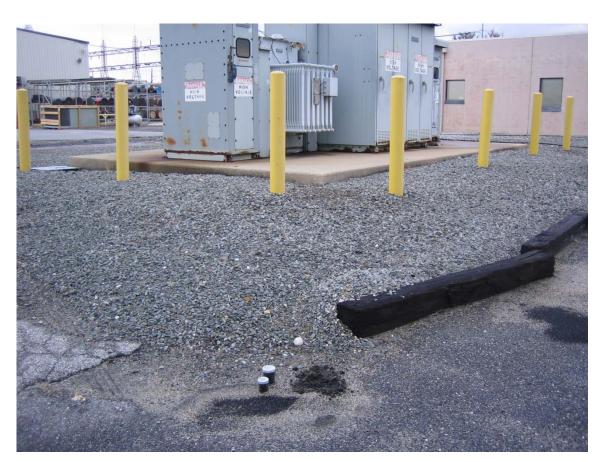
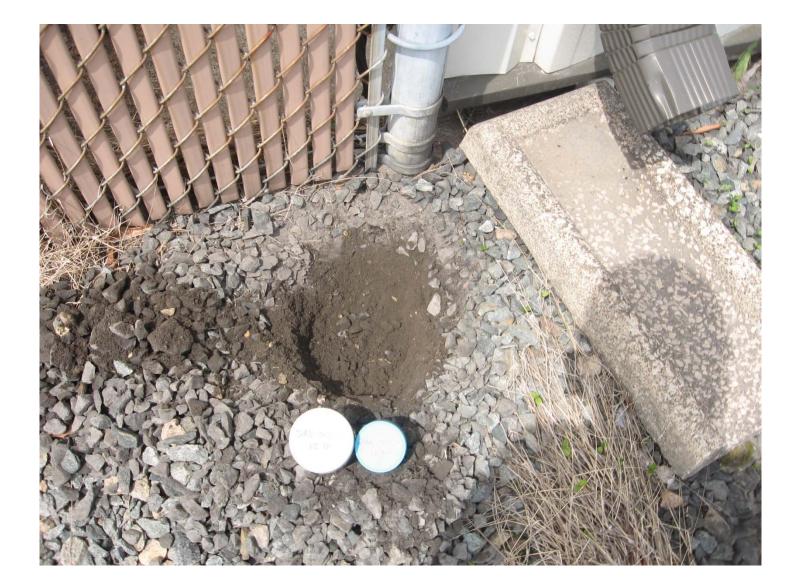
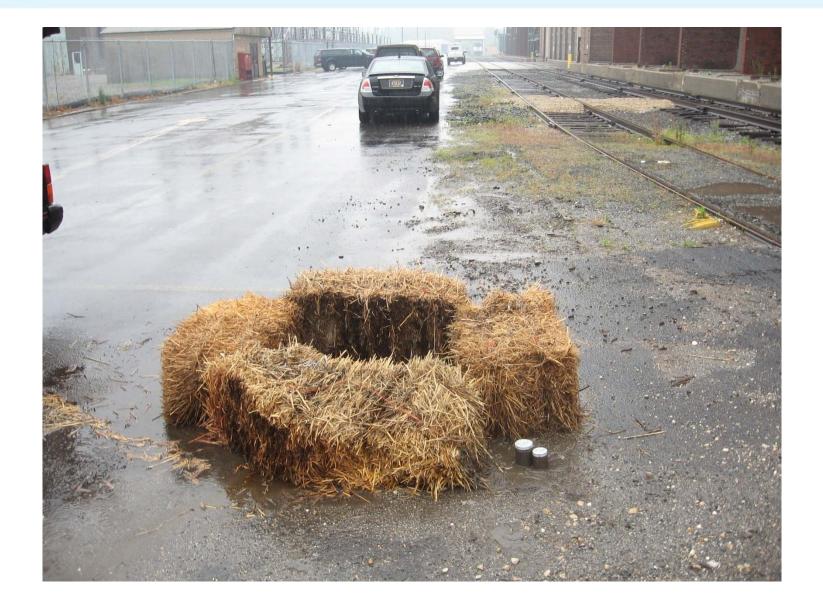
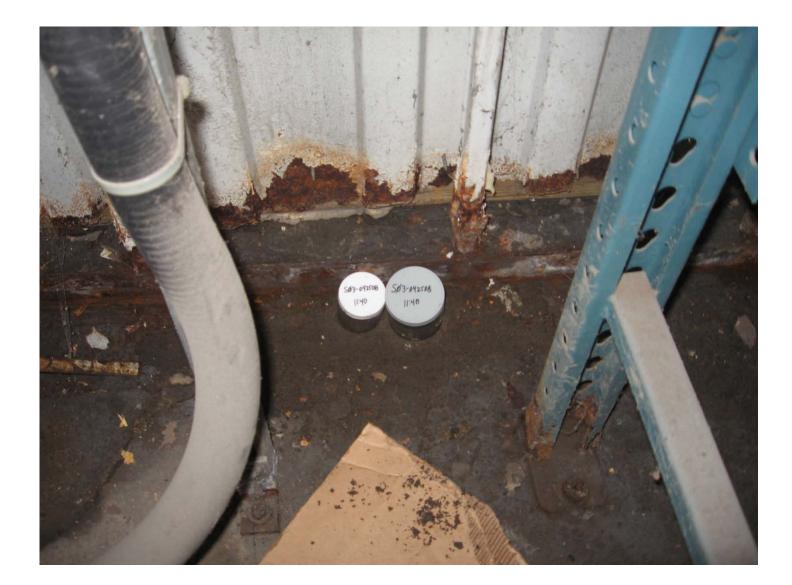
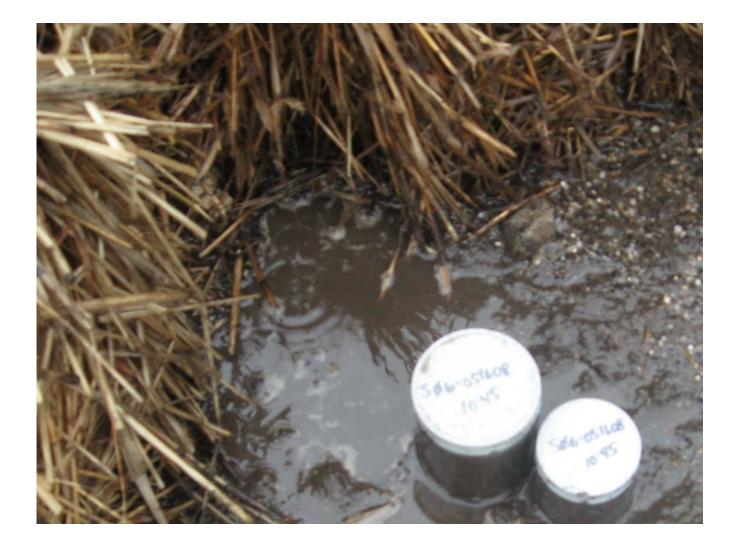
Collected surface sediment both within and adjacent to DSN 017 and 002 storm drains and at other strategic locations; analyzed using modified 8082 method (included ~50 congeners)

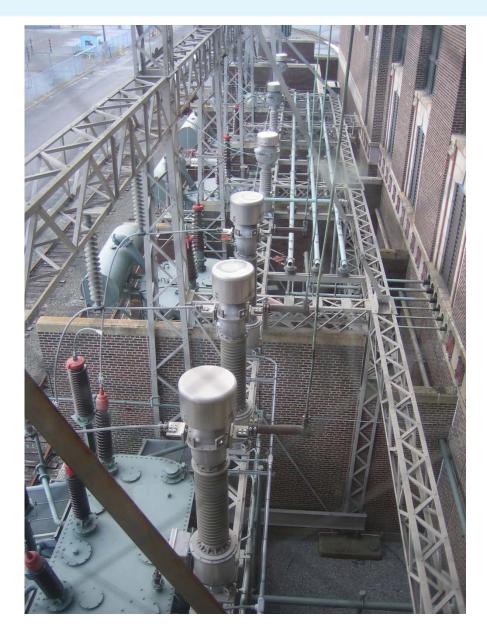
- Parallel sampling efforts were conducted around all transformer areas within 017 and 002
- Maximum PCB concentration was 0.99 mg/kg

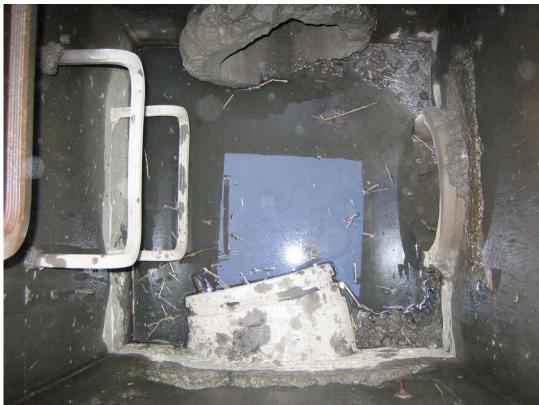
Proactively contracted to have DSN 002 and DSN017 piping and catch basins sealed off from the river and cleaned out. This effort addressed the potential for legacy contamination within the stormwater piping and sediments within catch basins.

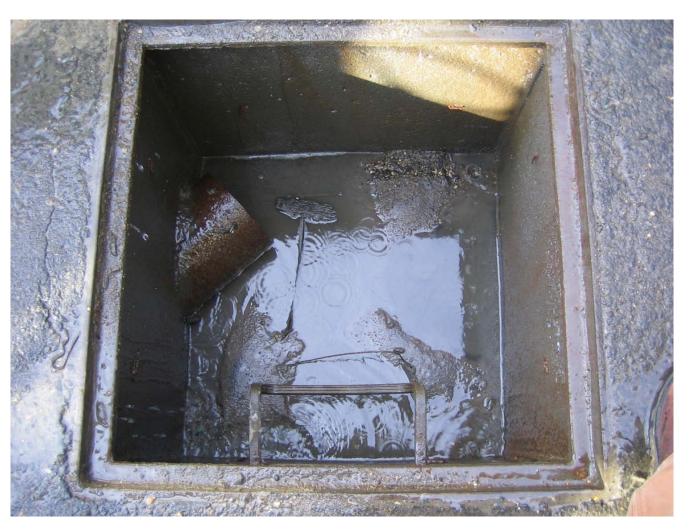
- Clean out of DSN 017 and 002 lines and catch basins
 - Sewer outfalls were first plugged to keep wash water from being discharged into the river.
 - Sediment was then flushed from two (12inch to 24 inch) storm sewer lines and approximately 16 associated catch basins.
 - ~2,200 ft of pipe was cleaned out.

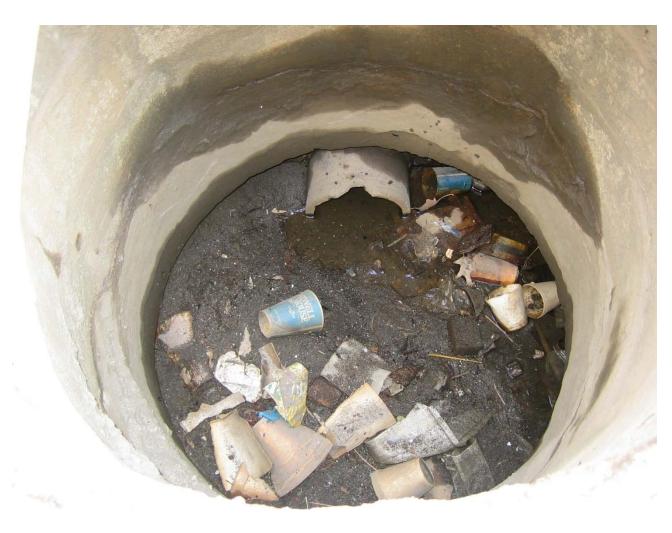
- Clean out of DSN 017 and 002 lines and catch basins
 - Samples collected and analyzed to characterize the sediment for proper disposal.
 - Effort took ~4 days
 - Cost <\$30k (2006)
 - ~8.1 tons of material removed and disposed

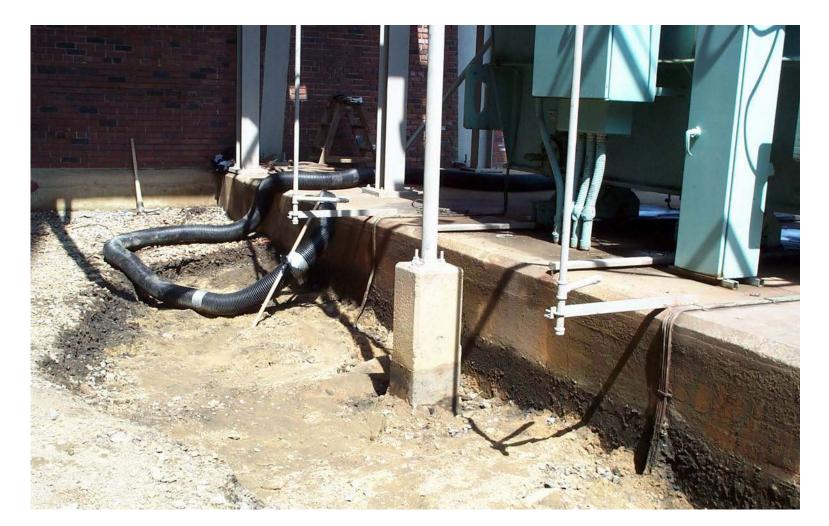
- Spot Removal of PCB impacted soils 2007-2009
 - Adjacent to transformers
 - over 600 g of total PCBs removed

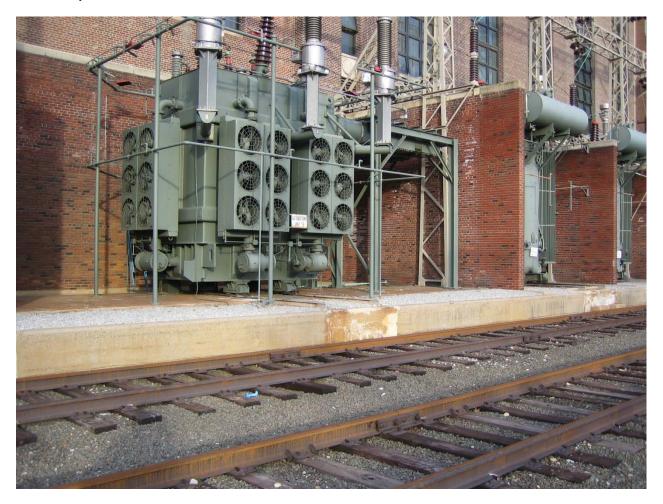
Several transformers and associated bushings adjacent to the power plant were removed for disposal.

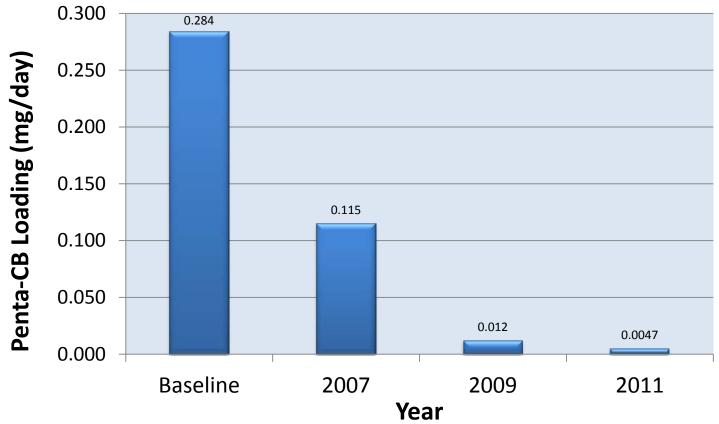
Penta-CB Loading at Deepwater Energy Center Outfall 017

Cumulative Reduction of Penta-CBs: 98.3%

- -Throughout the PMP implementation period to date, an estimated total mass of 29,354 grams of PCBs were removed from DSN 002 and 017 drainage areas through:
 - Complete removal of transformers and associated electrical equipment;
 - Retro-fitting/removal of dielectric fluids from transformers and other electrical equipment; and
 - Removal of PCB contaminated sediments.
- All PCB contaminated waste was properly disposed.

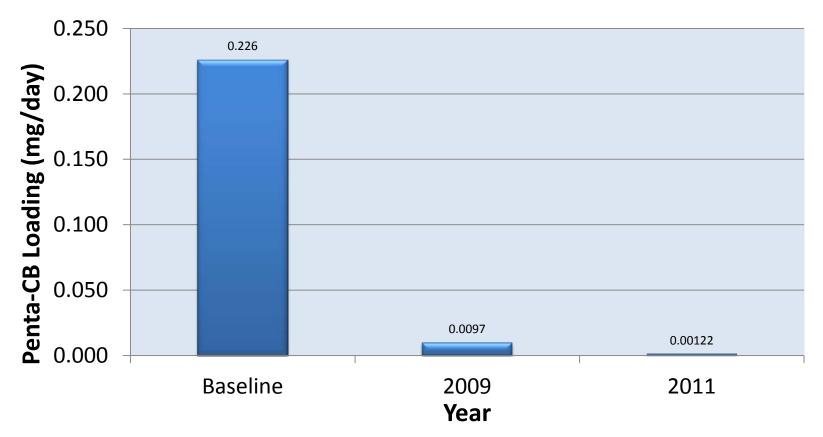
Penta-CB Loading at Deepwater Energy Center Outfall 002

Cumulative Reduction of Penta-CBs: 99.5%
